## SERVICE BULLETIN FAA/DAS APPROVED

NUMBER CSB-99-01  
DATE 7/19/99

SUBJECT: Brush wear in the 1C812-( )-( ) and 1C822-( )-( ) torque sensing pitch servos.

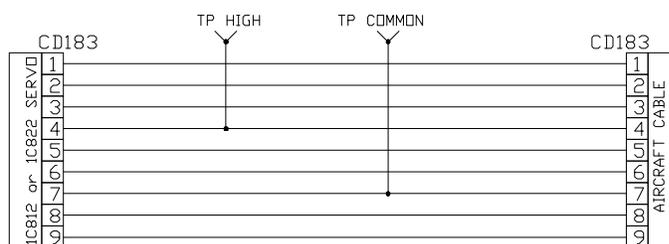
The servo can be tested in the aircraft by field fabricating and inserting a breakout test cable (see below) between the aircraft harness connector designation CD183 and the 1C812 or 1C822 pigtail connector designation CD183 and performing the following procedure.
