SERVICE BULLETIN
FAA/DAS APPROVED

NUMBER CSB-2002-01
DATE 1-21-02

SUBJECT: Intermittent Roll and Pitch Deviation

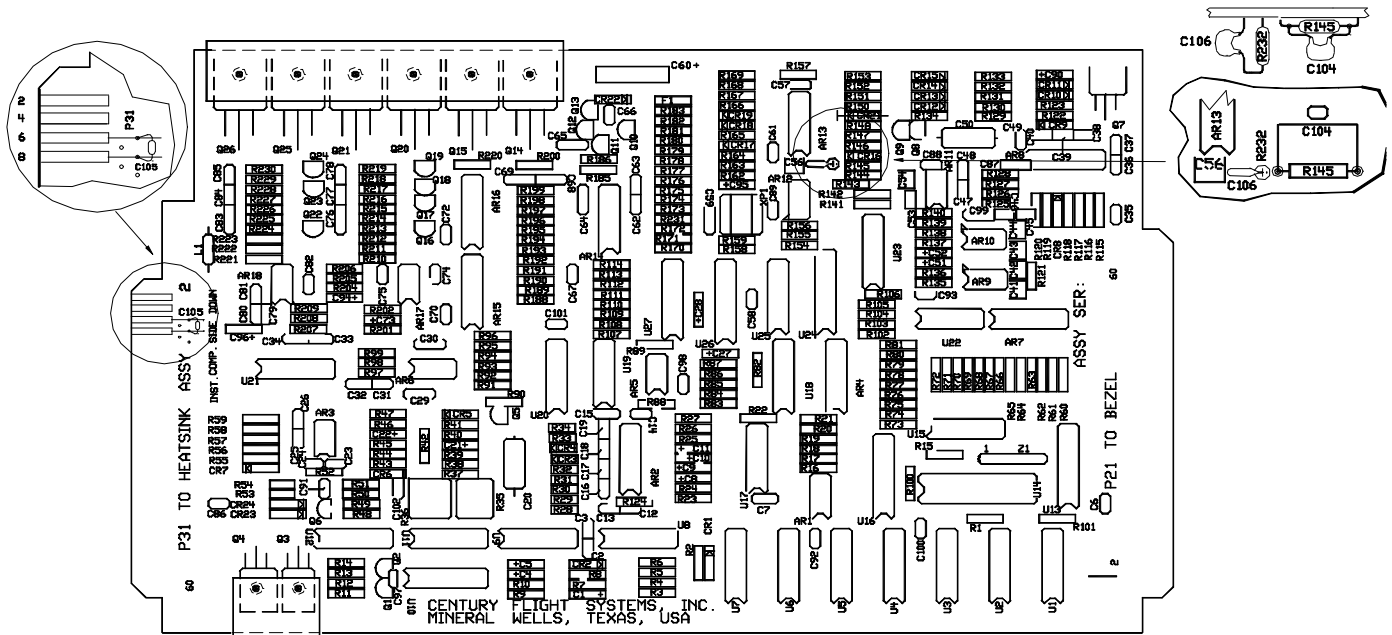
The following drawing depicts the modification to be made to the Century 2000 Basic Autopilot Circuit Board part number 81D664- () (28 volt aircraft) or 81D665- () (14 volt aircraft). This board is the bottom most circuit board.

1. Install a .1mf capacitor (C105) across pins 6 & 8 of edge connector P31. Use existing feed through holes at connector to secure capacitor.
2. Remove C55 from circuit board. Take a 1.5K (R232) resistor and connect one lead to one end of a .047mf capacitor (C106). Form resistor and capacitor as shown above. Connect other lead of R232 & C106 and connect to holes where C55 was located. Insure the lead of C106 is closest to body of C56 and no taller than local components.
3. Install a .01mf capacitor (C104) across resistor R145.
4. Install supplied placard to top cover at the front of the flight computer. If performing the requirements of this Service Bulletin from the Internet, make a placard from an address label with the following information:
